Chapter 6

ANALYSIS OF BUILDING EGRESS

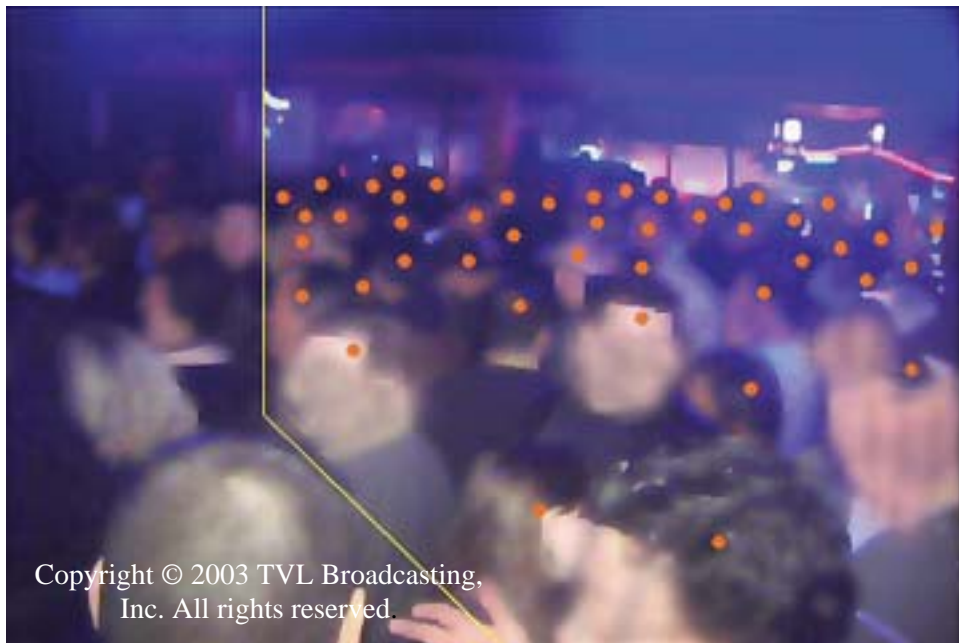
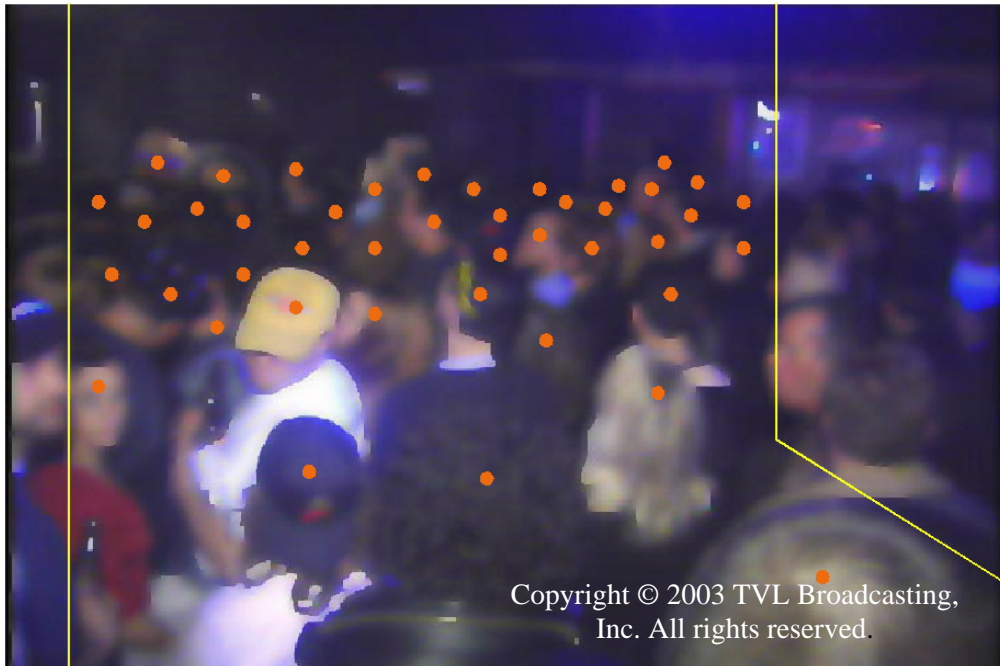
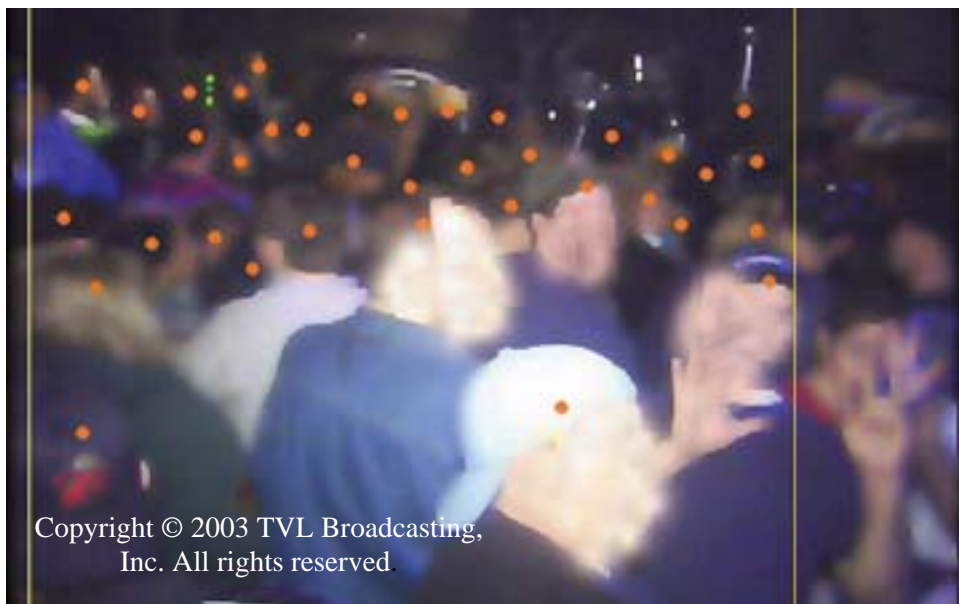
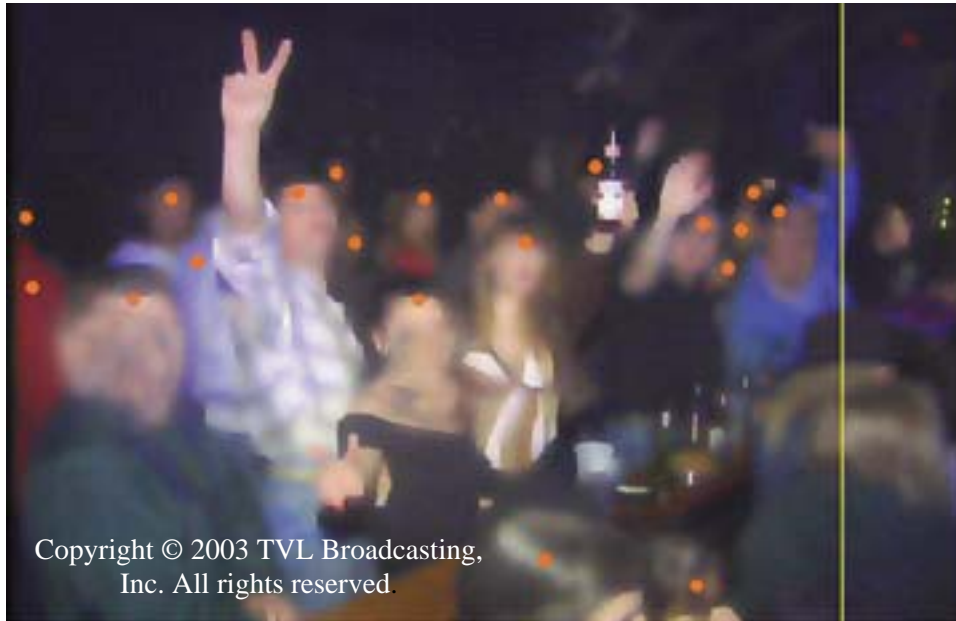
With the above limitations in mind, a series of still frames that provide a panning view of the club’s performance assembly area were obtained from the WPRI-TV video. These frames are shown in sequence in Figures 6-5 through 6-8 as the camera pans from right to left. The occupants shown in these still frames were counted in an effort to derive an approximate occupant load for the area shown. Orange dots have been used to represent counted occupants. The yellow lines in these Figures represent the boundaries where the frames overlap. A total of 144 occupants can be seen in these four figures.

Figure 6-5. Occupant Load Count, Part1 – 45 Occupants

Figure 6-6. Occupant Load Count, Part 2 – 42 Occupants

Figure 6-7. Occupant Load Count, Part 3 – 37 Occupants

Figure 6-8. Occupant Load Count, Part 4 – 20 Occupants

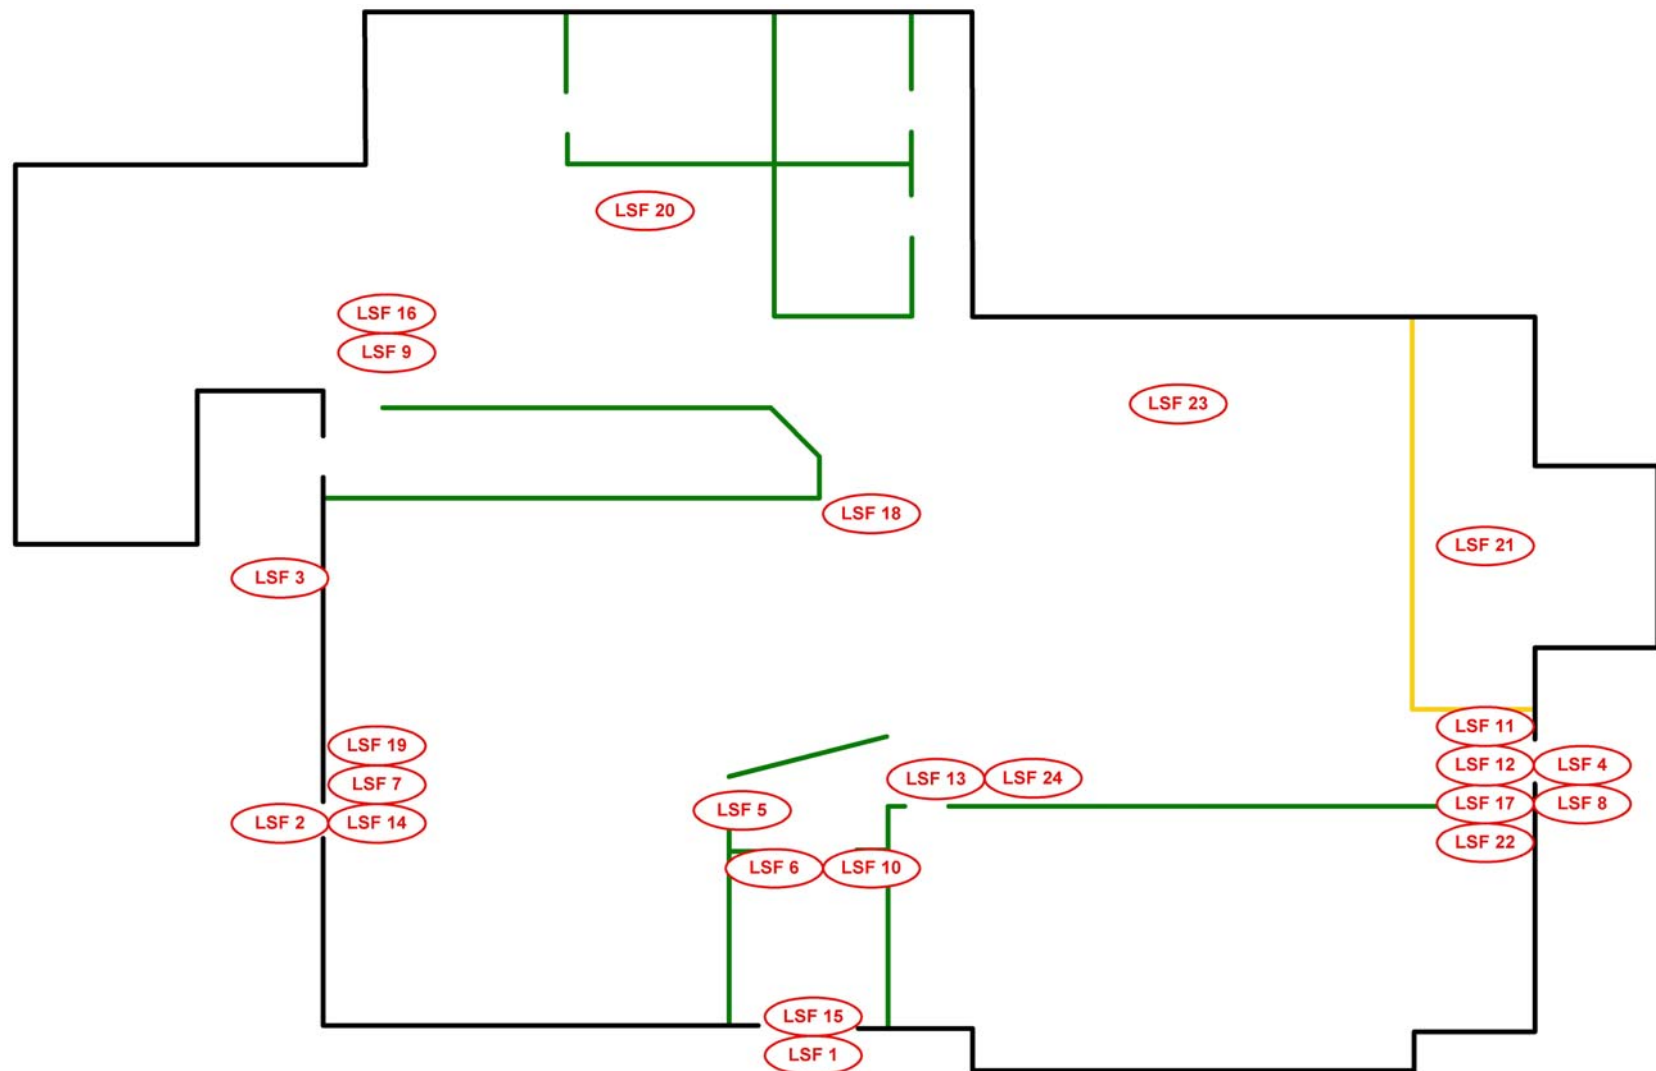
LSF 16.	Emergency light located near the rear bar.
LSF 17.	Emergency light above and to the right of the platform exit door.
LSF 18.	Emergency light on the wall adjacent to the kitchen by the main bar facing into the main floor area.
LSF 19.	Emergency light above and to the right of the left side exit door from the main bar area.
LSF 20.	Fire extinguisher located behind the rear bar.
LSF 21.	Detector (heat) located above the lighting grid on the ceiling near the platform.
LSF 22.	Fire alarm strobe adjacent to the exit sign above the platform exit door.
LSF 23.	Fire alarm strobe on the ceiling to the left and in front of the platform.
LSF 24.	Fire alarm strobe on the wall adjacent to the exit sign in the main floor area pointing toward the ticket area.

Figure 6-9. Locations of life safety features listed in Table 6-1.

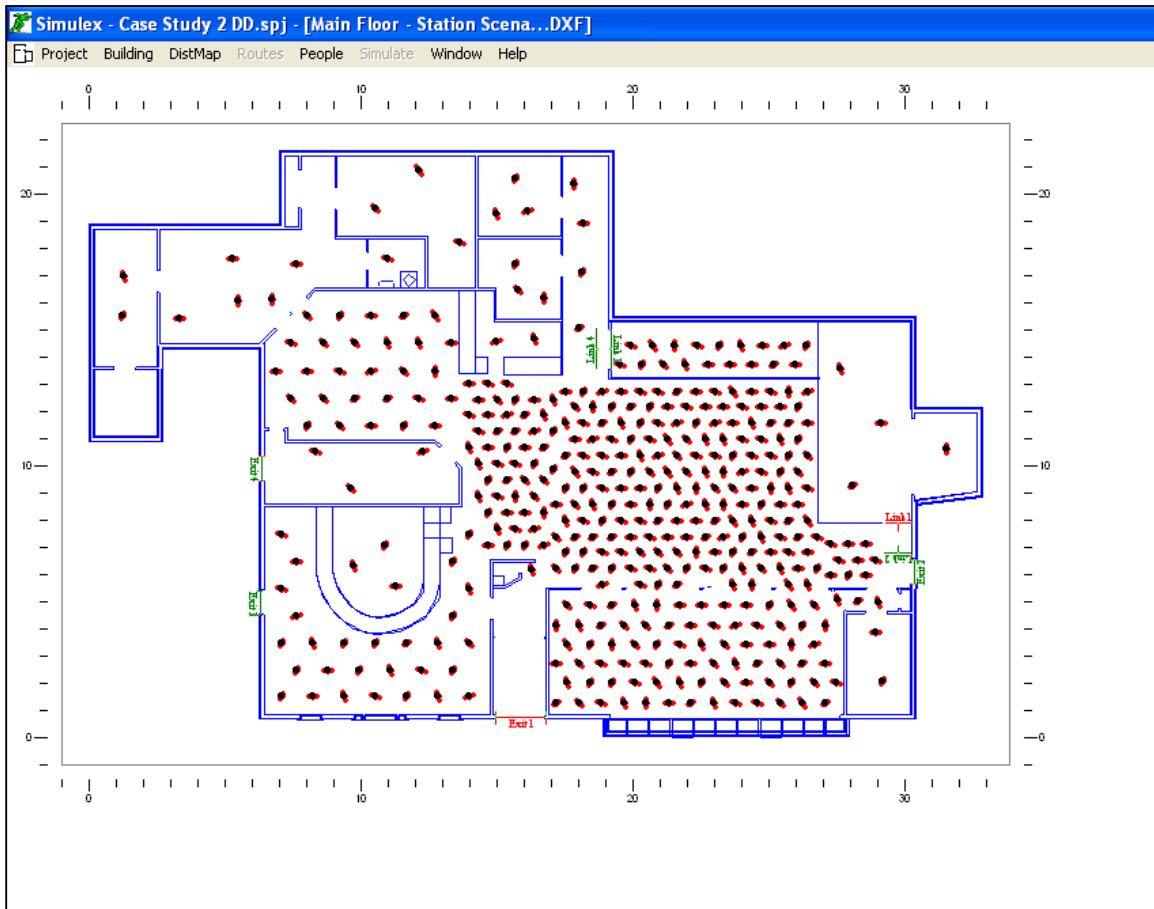
Scenario 3 investigated the impact of *doubling the width of the most restrictive element at the front entrance*. Figure 6-15 is one frame grabbed from the Simulex computer simulation indicating the initial

Figure 6-15. Initial distribution of 420 simulated nightclub patrons and employees

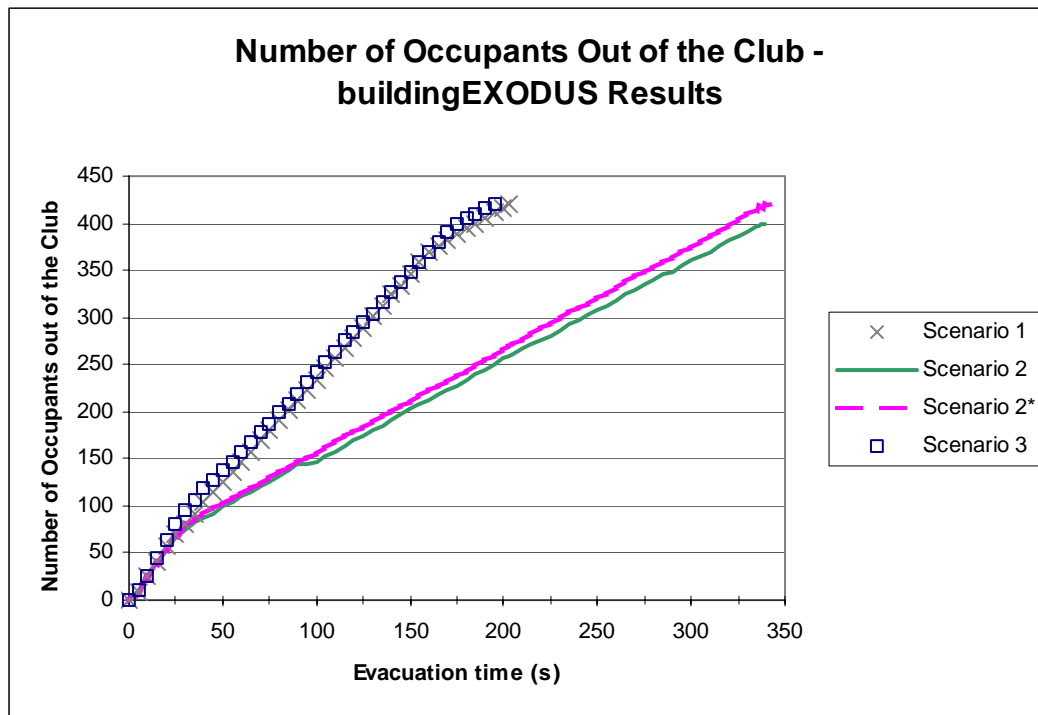
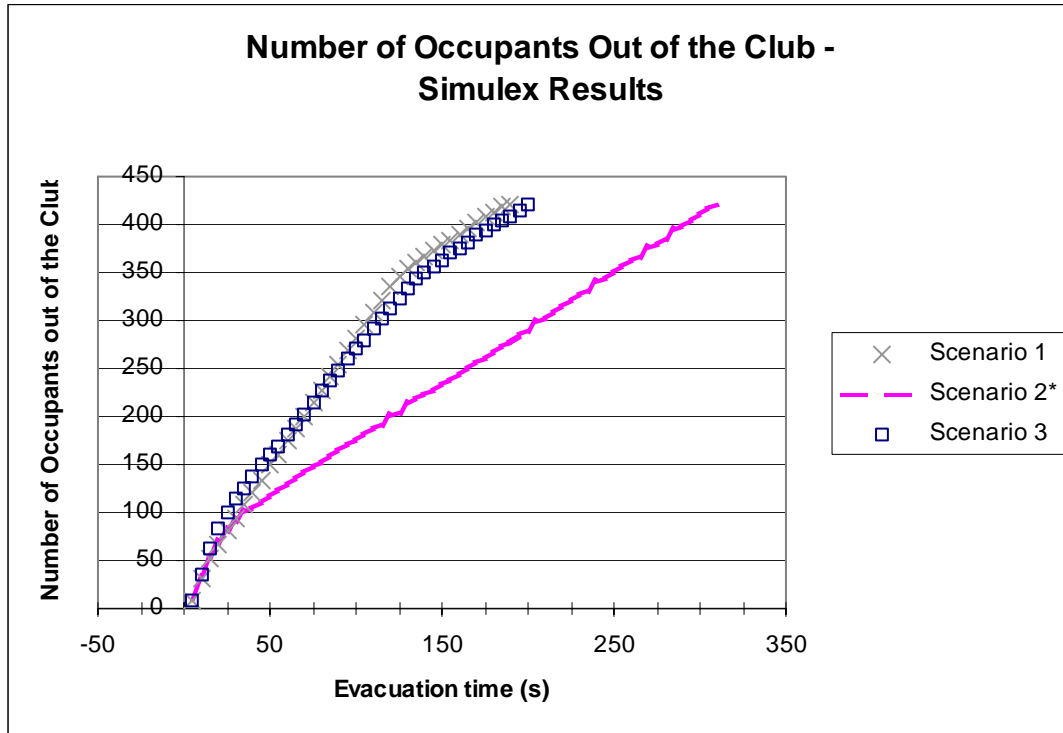
Figures 6-16 and 6-17 compare the cumulative population that was evacuated as a function of time for the scenarios described above, based upon the results of buildingEXODUS [39] and Simulex [37, 38] respectively. If one draws a vertical line up from the time scale at 90 seconds, the total number of people who remained in the nightclub at that time can be determined.

Ninety seconds had significance on Feb. 20 because that was about the time the front entrance became blocked and, according to the fire dynamics simulations, was a point where the conditions were becoming untenable throughout the building. The last column in Table 6-2 lists the population remaining for both the buildingEXODUS and Simulex simulations. Note that buildingEXODUS, when compared to Simulex, consistently provided a more conservative (i.e., a slower) rate of egress, which is consistent with the conservative flow rates chosen for the exit doors in buildingEXODUS.

Somewhere between 166 and 208 people were calculated to remain in the building 90 seconds after the fire began for the scenario in which the building met current national model code requirements. This number jumped to 271 for scenario 2, with the platform door blocked (recall that the front door remained open during the first 90 seconds). Doubling the entrance door width in scenario 3 brought the number of people remaining in the building 90 seconds into the fire back down to the range calculated for scenario 1. Finally, since the crowd-crush had not occurred prior to 90 seconds, the calculation for the 2* scenario is essentially the same as for scenario 2.

Figure 6-16. Cumulative plot of evacuation from building for different scenarios calculated from buildingEXODUS [39]

Figure 6-17. Cumulative plot of evacuation from building for different scenarios calculated from Simulex [37, 38]
